# **Lakefront Building Structural Evaluation**

### **Lakefront Building Structural Evaluation**

Site Address: 454 Lake Street Fontana, Wisconsin 53125

**Structural Evaluation**

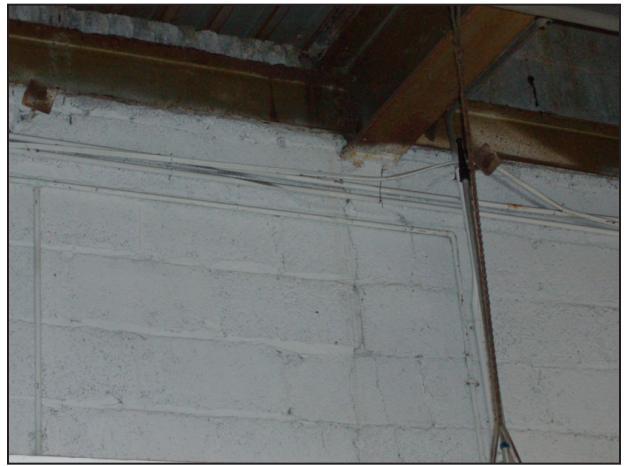
Photo 4: CMU cracking at column location

Some of the cracks are located at the columns which is a normal and expected location for the wall to crack (Photo 4). Most of the wall cracks are diagonal stair-step cracks located near the window openings (Photo 5). These cracks do not appear to have formed recently; however, it is unknown whether they are actively moving or if they are stagnant. The source of this cracking is not obvious at this time. Some of the cracks are consistent with foundation settlement. Others are consistent with lateral drift of the building.

The diagonal wall cracks should be monitored to determine whether they are active cracks. This can be accomplished by measuring the cracks at specific locations and periodically checking the measurements to determine whether they have moved. Alternately, crack monitors could be installed across the cracks and periodically checked for movement. The crack monitors would give a better idea of the magnitude and direction of movement. Both of these methods will allow tracking of long term movements.

There is a possibility that the cracks have formed due to structure drift (lateral deflection of the roof). If this is the source of the cracking, then periodic checking of the cracks is not likely to provide any information. The most cost effective way to check for these movements would be to repair the cracks by repointing the cracked joints. If the cracks reappear, they are active cracks and may be related to structure drift. It may take a significant period of time for the cracks to reappear. This option would be preferable also because it will strengthen the building walls providing more resistance to wind against the building.

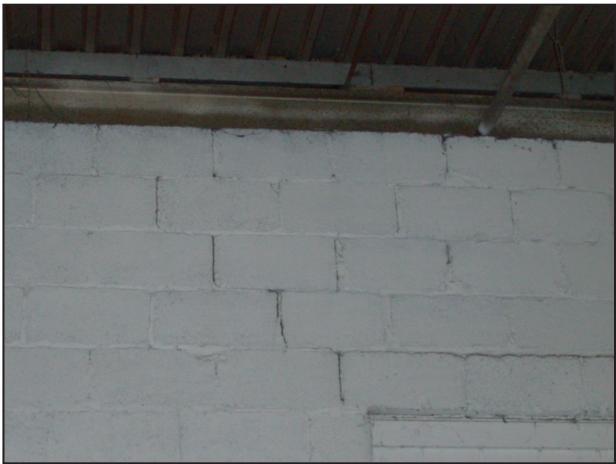
Photo 5: CMU cracking at window opening

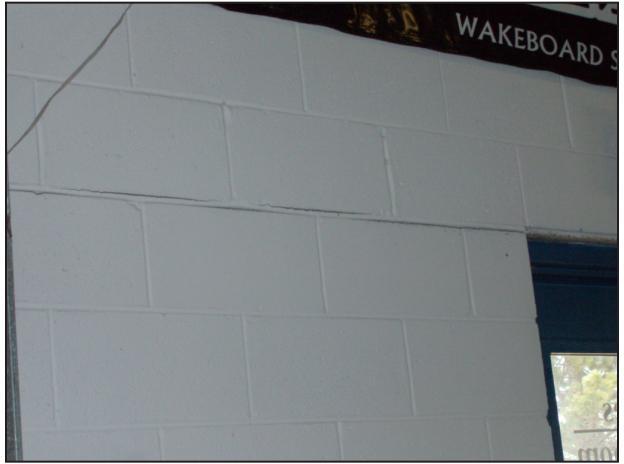
Photo 6: Horizontal CMU crack at window infill

A relatively large horizontal crack was noted in the infill CMU at the east end of the north wall (Photo 6). This crack is consistent with an inward horizontal load against the wall.

The horizontal crack in the CMU infill at the east end of the north wall should be repaired. We recommend that some additional exploratory investigation be performed in this location to determine the source of the cracking. The repair for this condition would likely be replacing the infill with new CMU or providing strongbacks along the wall at this location.

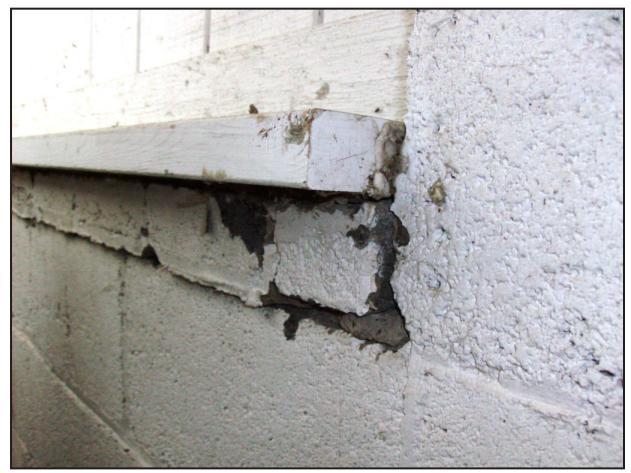
One half-height course of CMU below the south window on the east elevation of the

Photo 7: CMU window jamb displacement

original building has moved inward (Photo 7). The reason for this movement is unknown, although we suspect that it may be related to the installation of the new window or the siding. Invasive investigation would be required to determine the source of the movement.

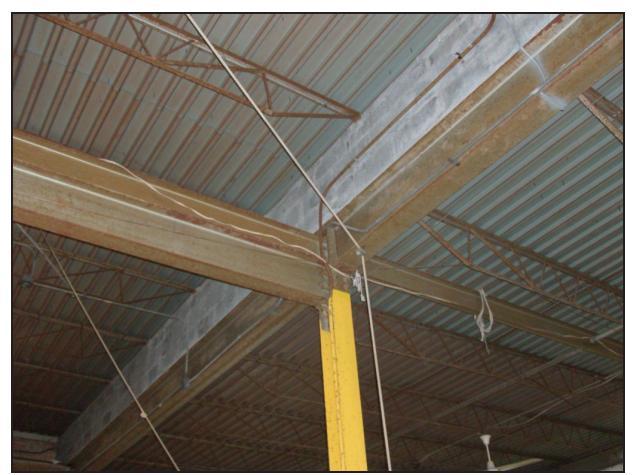
Photo 8: Steel roof framing

The roof structure is composed of 1  $\frac{1}{2}$ inch metal deck spanning between 14 inch deep steel joists (Photo 8). The steel joists are supported on 14" deep steel Ishape beams which bear on 6 inch I-shape columns. The framing layout is a 3 bay x 3 bay pattern with 25 foot bays in each direction. Some additional framing for a small crane is located in the center bay (Photo 9). The roof heights near the center of the building are approximately 14 feet in the north and south bays and 16 feet in the center bay. These measurements are approximate and were taken from the top of the slab to the bottom of the deck.

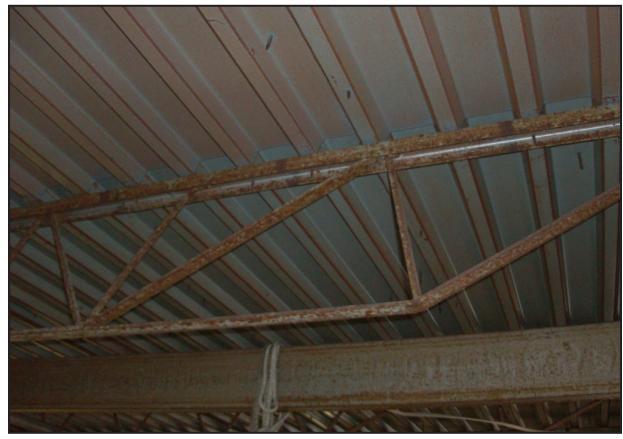
The roof structure is in fair to good condition. Some surface rust was noted on the joists, beams and columns, however none of the rust is structural significant at this time (Photo 10). The roof framing appears to be performing as intended without significant deflection, deterioration or damage.

Photo 10: Surface deterioration of steel joists and beams

For the longest life of the building, we recommend cleaning and painting the

steel elements of the roof system in the original building to protect the steel from further corrosion. This is not required for structural capacity, but will provide protection that will extend the life of the building.

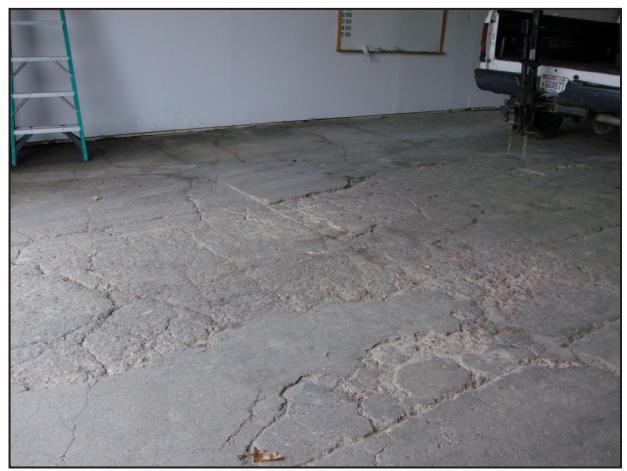
Photo 11: Concrete slab on grade condition

The floor of the building is a concrete slab on grade and is in poor condition. The slab has substantial cracking and is extremely uneven (Photo 11). The floor elevation is lower than, or even with, much of the surrounding exterior grade. The asphalt from the parking lot is higher than the floor slab at the rear overhead door entrance (Photo 12).

The concrete floor slab is in very poor condition. We recommend replacing the slab with a new concrete slab on grade. This is not a structural component and is not required to be replaced, but is recommended for usability of the building.

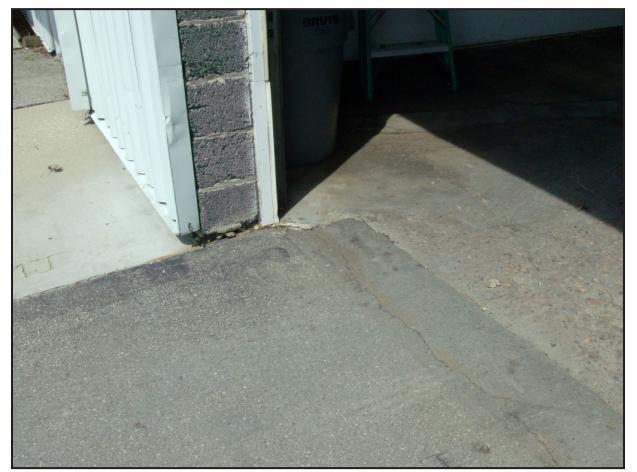
Photo 12: Asphalt parking lot extends into building

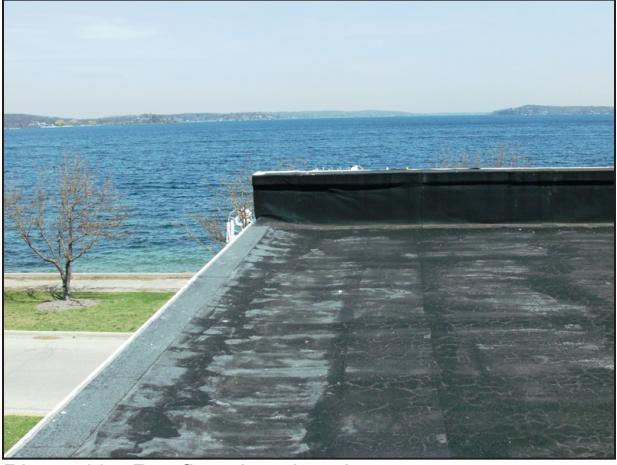
The roof is a built up roof. It is our understanding that the roof was last replaced in 1991. The roofing has reached the end of its expected life. The top layer of tar has worn away and the layer of felt below is exposed in many areas (Photo 13).

Photo 13: Roofing deterioration

An additional layer of built up roofing should be applied to the building. At that time, the built up roof can be placed on top of the roll roofing at the edge of the building to allow proper water flow. Also, metal cap flashing should be installed at the parapet wall.

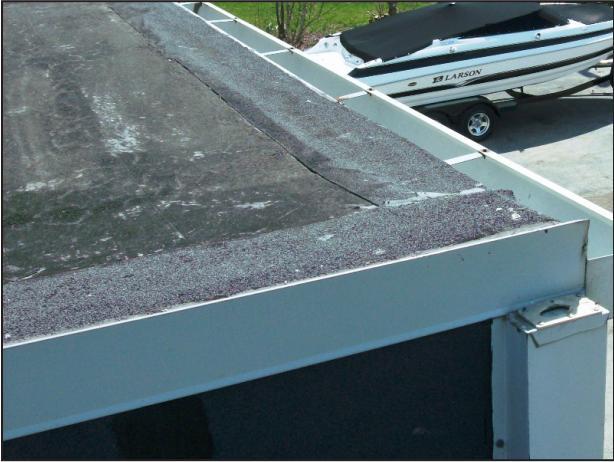
In addition to the normal deterioration observed, there also are two areas of concern relating to water flow and drainage paths. A strip of roll roofing has been placed along the edge of the built up roof adjacent to the gutters (Photo 14). The lap between the two roofing materials is directed such that water can get below the roofing and into the building. The second area of concern is at the east parapet. When the vinyl siding

Photo 14: Lap with roll roofing at roof edge

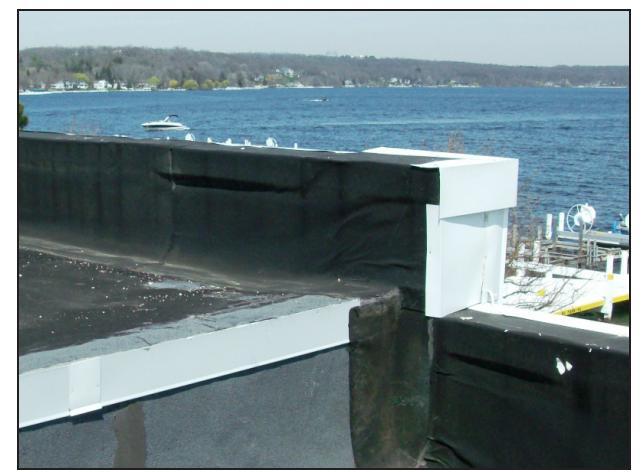
was installed on the front of the building, the top angle of the siding was placed on the parapet without a metal cap flashing over the parapet (Photo 15). This can allow water to get behind the siding rather than directing water to the exterior face of the siding.

Photo 15: No cap flashing at front parapet

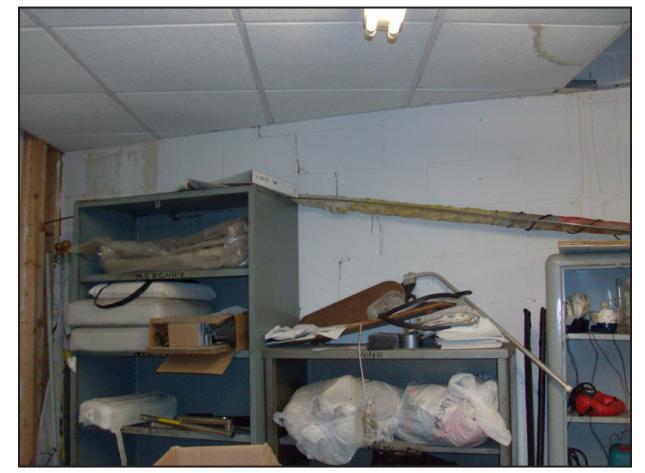
Much of the south addition building structure was not visible due to wall, floor and ceiling finishes. One crack was noted in the south wall (Photo 16). The crack did not appear to be structurally concerning. The roof structure was not visible. Roof leaks along the south wall may have caused deterioration of the structure depending on the construction type. There are two levels of ceiling in the south addition. The upper ceiling tiles have the appearance of tiles which may contain asbestos.

Photo 16: CMU crack in south addition wall
